UNITED STATES
DEPARTMENT OF THE INTERIOR
BUREAU OF RECLAMATION

HYDRAULIC MODEL STUDIES OF THE MODIFIED
OUTLET WORKS STILLING BASIN
NAVAJO DAM
COLORADO RIVER STORAGE PROJECT
NEW MEXICO

Report No. Hyd-573

June 15, 1967

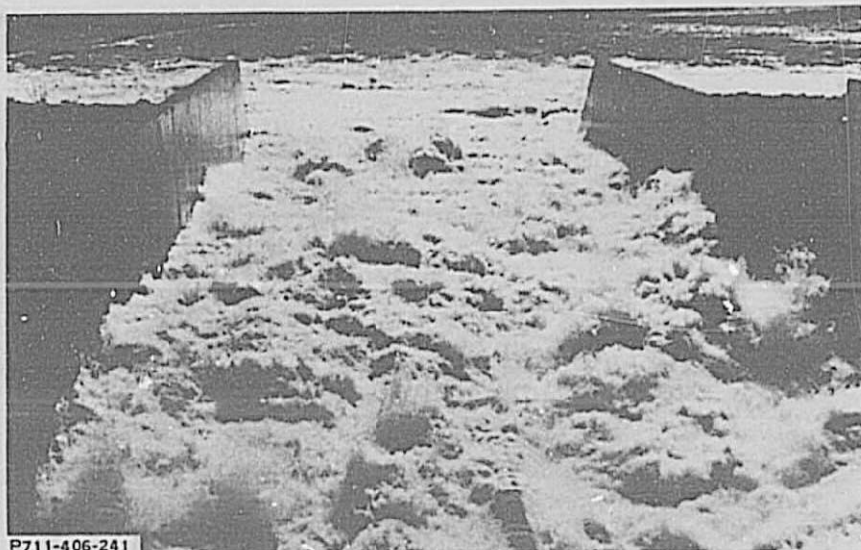
Figure 9
Report Hyd-573

Discharge $\approx 3,900$ cfs
Valve opening = 100 percent
Reservoir elevation 5098.2
Tailwater elevation ≈ 5715

Original Configuration
Prototype Operation

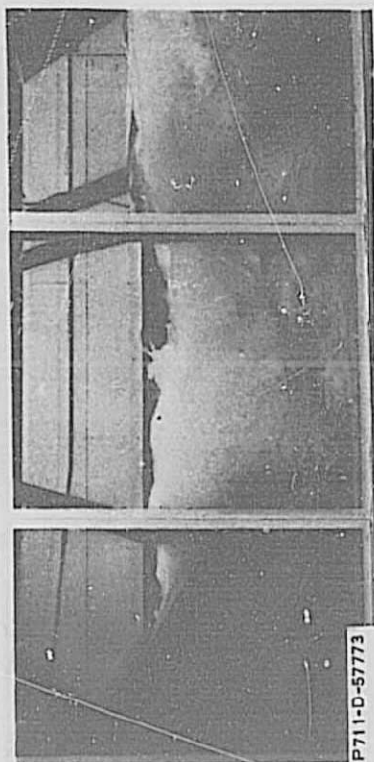
P711-D-57773

At tailwater elevation 5715.3, the top of the center wall was exposed to view and the jump profile was relatively steep, Figure 14. The jets turned upward from the floor at a point 20 to 30 feet downstream from the end of the center wall. Surface turbulence and foam extended beyond the basin into the downstream channel. Material circulated very rapidly on the basin floor between the end of the center wall and the dentated end sill. Moderate vortex action occurred on the right outside wedge and flow was generally downward along the downstream face of the wedge. Moderate to strong wave action existed in the downstream channel.

Right side view of stilling basin. $Q = 3,940$ cfs, both valves open 100 percent, reservoir elevation 6000, tailwater elevation 5715.3.

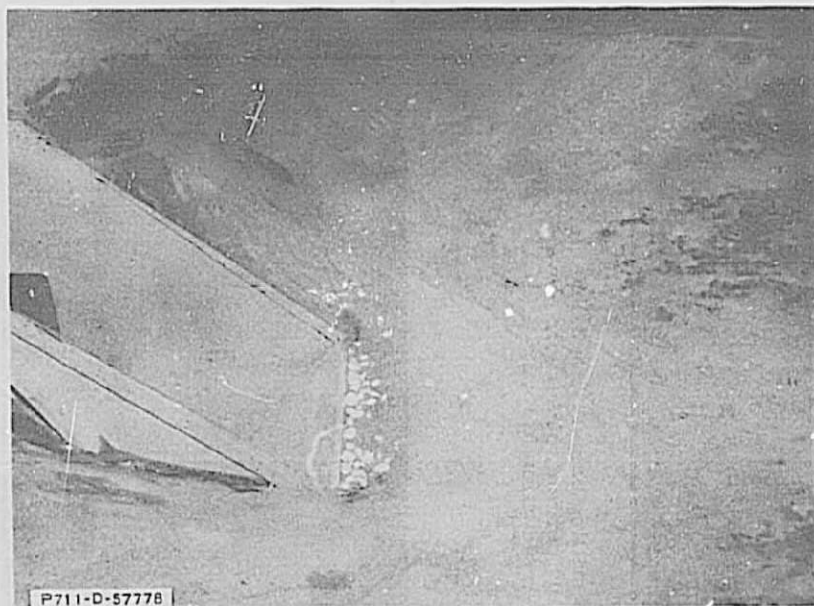
The model was operated for 4 hours at $Q = 3,940$ cfs, both valves 100 percent open, reservoir elevation 6000, tailwater elevation 5715.3. The test resulted in minor damage to the basin floor between the end of the center wall and the end sill, Figure 15, corresponding to the damaged area in the prototype basin. Damage to the end sill could not be determined because some of the paint had peeled. It appeared that a large portion of the aggregate added during operation had been swept from the basin and sand had been pulled into the basin, Figures 14 and 15. Material was deposited everywhere on the horizontal floor but the largest amount was deposited between the end of the center wall and the end sill, Figure 15. Sandpiles were noted on the upstream side of the individual dentils.

Condition of downstream channel after 4 hours
operation at Q of 3,940 cfs (Figure 14).

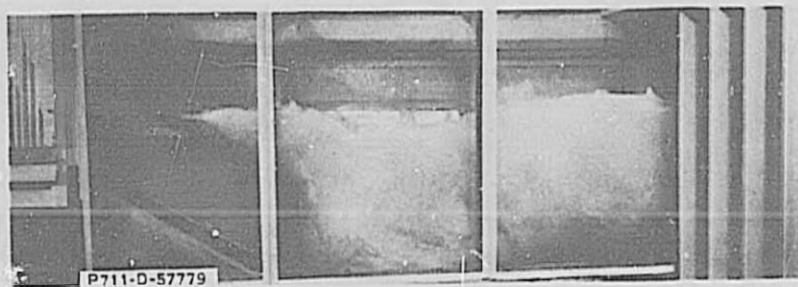
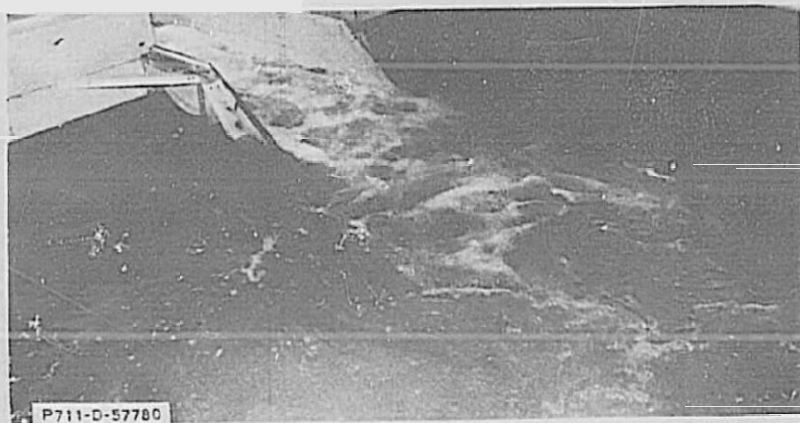
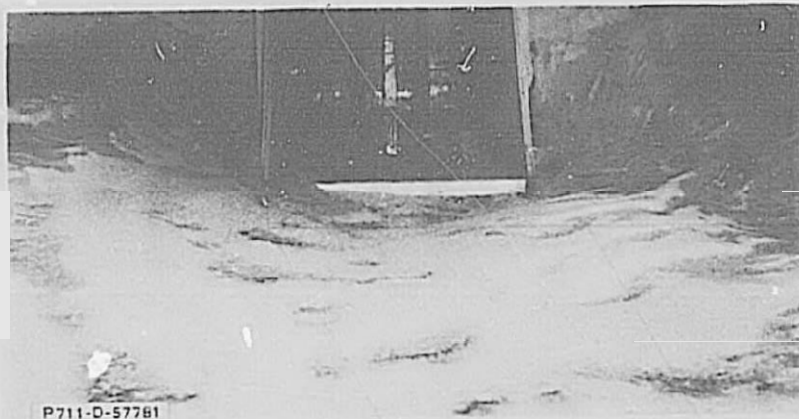
Figure 17
Report Hyd-573

Both valves 51 percent open, $Q = 3,200$ cfs, reservoir elevation 6101.6 ($H = 382$ feet), tailwater elevation 5715.0. --The model of the original configuration was also subjected to flows corresponding to operation at maximum reservoir elevation for a period of 4 hours. The stilling basin water surface was essentially level, with surges rising about 5 feet above the downstream end of the center wall. The surface boil was fairly evenly distributed from the end of the center wall to the downstream end of the basin, Figure 17. Wave heights in the downstream channel were about 1-1/2 feet from trough to crest. Moderate swirling occurred along the downstream face of the right outside wedge. Several pieces of coarse gravel placed in the basin were observed to circulate throughout the turbulence.

Scour in the downstream channel was localized at the end of the stilling basin, Figure 17. Some material was washed down the slopes on the outside of the basin walls. Only a few pieces of coarse sand were pulled into the horizontal portion of the stilling basin. The deposits of fine sand on the sloping apron and near the dentated end sill were apparently the result of sloughing of the channel banks during drainage of the model.

Right-side view of stilling basin. $Q = 3,200$ cfs, both valves 51 percent open, reservoir elevation 6101.6, tailwater elevation 5715.0.

Condition of downstream channel after 4 hours at Q of 3,200 cfs.

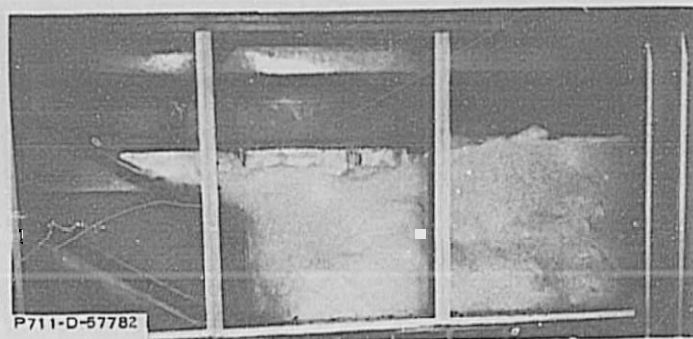
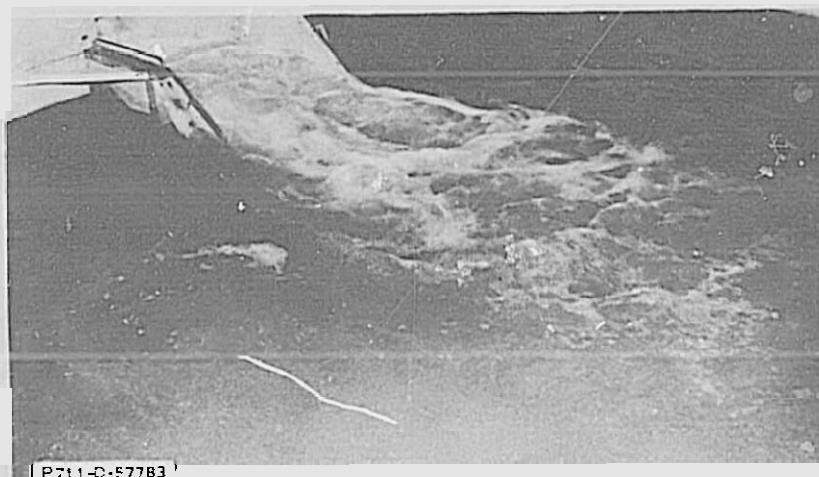
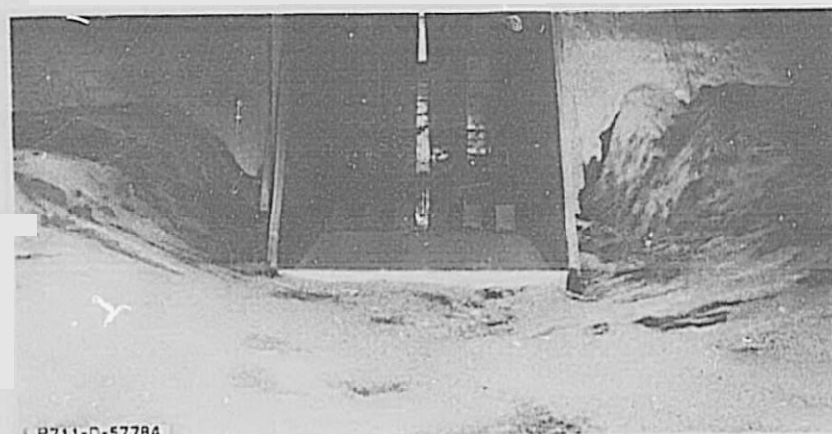
Figure 18
Report Hyd-573

Both valves 100 percent open, $Q = 4,720$ cfs, reservoir elevation 6101.6 ($H = 382$ feet), tailwater elevation 5715.5. --The model was operated for 4 hours under these conditions, which represent the maximum operating conditions for the outlet works. The jets remained on the floor through the horizontal portion of the basin and occasionally turned upward near the downstream end of the viewing section. The water surface was essentially level and varied in height from near the top of the center wall to about 5 to 8 feet below the top of the wall. An intermittent boil rose near the downstream end of the center wall and a constant boil existed in the downstream portion of the basin, Figure 18. The downstream boil was fairly well distributed across the basin and varied from 5 to 8 feet in height, with a maximum height about 8 feet below the top of the outside walls. Some of the boil spilled over the sloping side walls at the downstream end of the basin.

Although about one-half handful of coarse sand and several pieces of coarse gravel had been placed on the sloping apron in the downstream portion of the basin before the test, no material could be seen circulating near the viewing window. There was moderate swirling along the downstream face of the right outside wedge. Waves in the downstream channel were about 2 feet high. Scour in the downstream channel was again limited to the area immediately downstream from the basin, Figure 18, and there was some down-slope washing of the channel slopes outside the basin walls. The coarse sand which was originally placed on the sloping apron was deposited in the horizontal

Right-side view of stilling basin, $Q = 4,720$ cfs, both valves 100 percent open, reservoir elevation 6101.6, tailwater elevation 5715.5.

Condition of downstream channel after 4 hours at Q of 4,720 cfs.

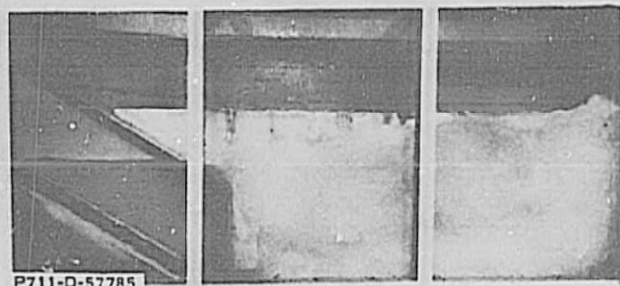
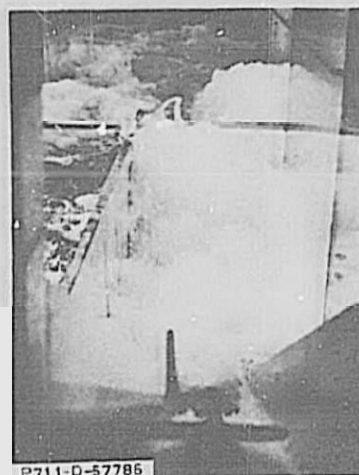
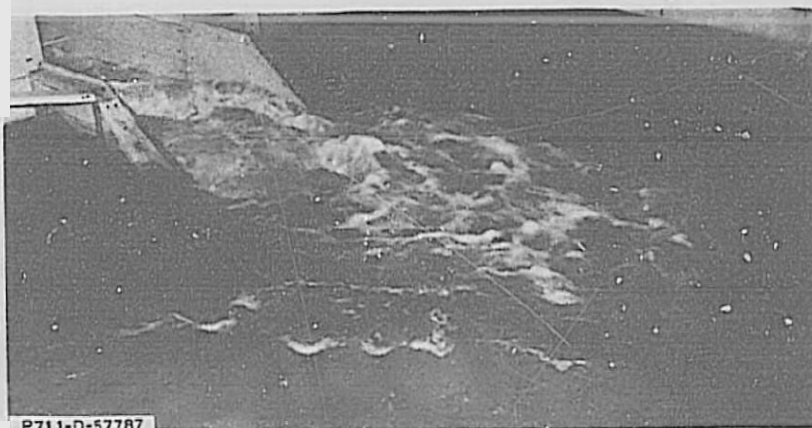
Figure 19
Report Hyd-573

Right valve only 100 percent open. $Q = 2,790$ cfs, reservoir elevation 6101.6 (H = 382 feet), tailwater elevation 5714.8. -- Limited observations were made for one-valve operation, Figure 19, which would be allowed only under emergency conditions when one valve was inoperative. Pressures on the center wall were not recorded, but there was no doubt that the combination of low tailwater and turbulence on one side of the wall and high static tailwater on the other side of the wall would cause severe loading conditions. Also, circulation in the downstream end of the basin would pull large amounts of sand and gravel from the downstream channel into the nonoperating side of the basin.

Right-side view of stilling basin. $Q = 2,790$ cfs, right valve alone 100 percent open, reservoir elevation 6101.6, tailwater elevation 5714.8.

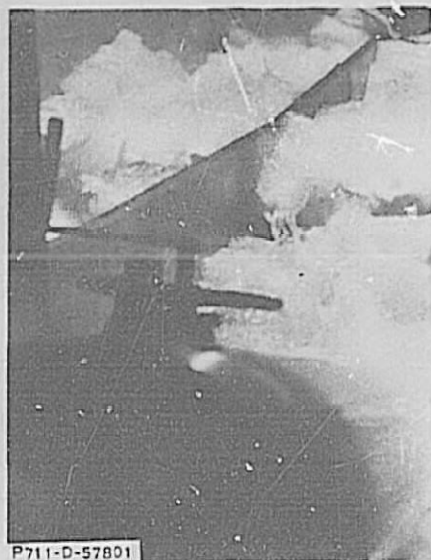
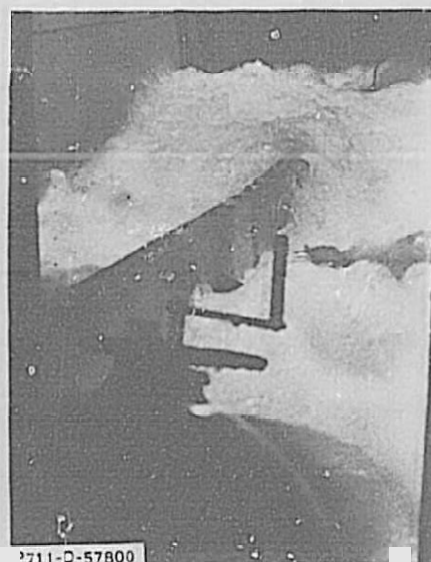
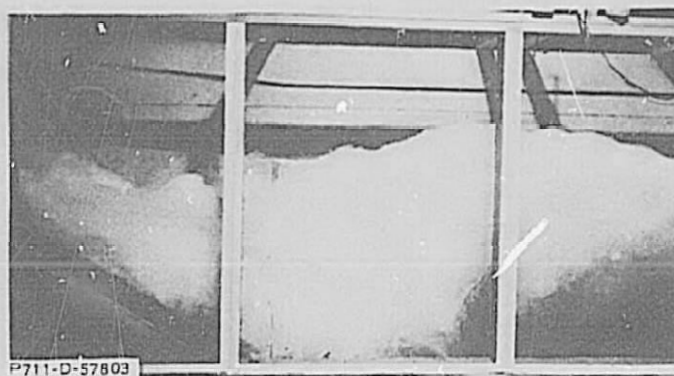
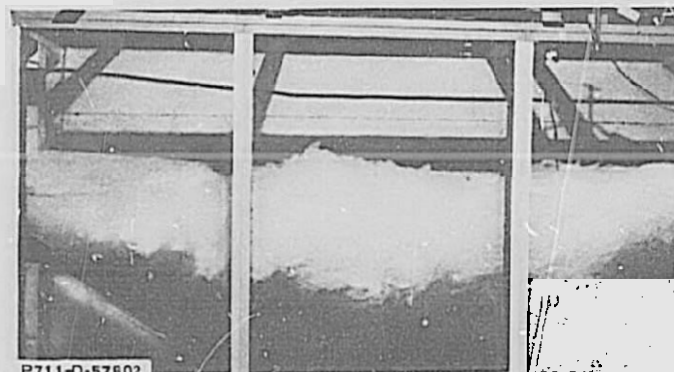
Figure 21
Report Hyd-573

The model was operated at $Q = 1,840$ cfs, Figure 21A, and, in general, flow conditions were not as good as those observed with the wedges in place. Jet penetration was inadequate as evidenced by the very rough water surface in the basin and strong wave action in the downstream channel. Abrasive material added to the basin circulated slowly on the chute floor beneath the jets. Pressure fluctuations on the center wall were recorded with the tailwater at elevation 5714.4. The magnitude, frequency, and pattern of the pressure fluctuations, Table 2, were very similar to those observed for the original configuration. The vibration frequency was also similar, although a good comparison could not be made because of the reduced stiffness of the wall when the wedges were removed.

With the valves 100 percent open, $Q = 3,940$ cfs, reservoir elevation 6000, Figure 21B, the jets turned upward from the basin floor approximately 25 to 30 feet upstream from the corresponding point observed with the original configuration. A high boil formed near the downstream end of the center wall and at times overtopped the side walls (elevation 5728). Abrasive material circulated violently in the turbulence and on the chute floor beneath the jets. Wave action in the downstream channel was moderate. The resulting scour pattern on the channel bottom indicated a high downstream bottom velocity similar to that observed in the original configuration for 32 percent valve opening. It was also noted that the abrasive material circulated higher in the flow than it had with the wedges in place. Pressure fluctuations and vibrations on the center wall for tailwater elevation 5715.3, Table 2, were again very similar to those recorded with the wedges in place.

Right-side view of stilling basin, $Q = 3,940$ cfs,
both valves 100 percent open, reservoir elevation 6000, tailwater elevation 5715.3. Bottom turbulence is next to center wall and is not visible in this view.

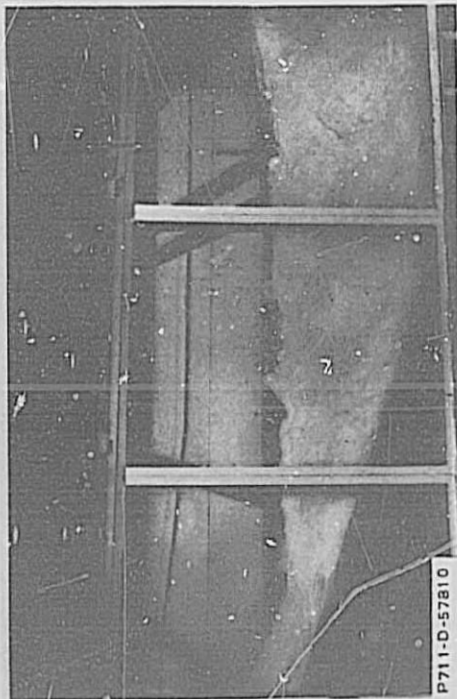
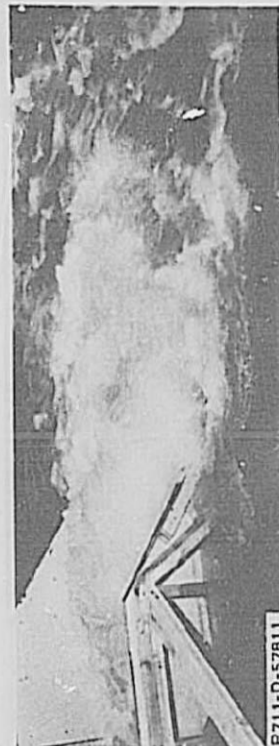
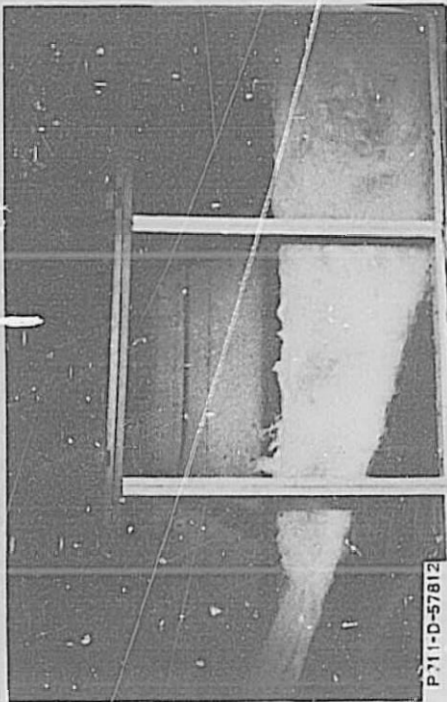
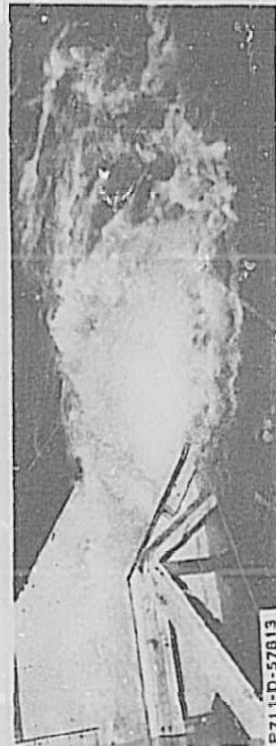
Figure 25
Report Hyd-573

throughout the horizontal portion of the stilling basin. At the maximum discharge of 4,720 cfs, Figure 24A, a large surface boil formed at the downstream end of the stilling basin. Flow conditions inside the stilling basin were quite good. One-valve operation at 2,790 cfs, Figure 24B, resulted in very rough surface flow conditions at the downstream end of the basin; however, flow conditions within the basin were tolerable. Circulation of coarse sand which originated in the downstream channel was apparent. Operation at $Q = 1,840$ cfs, Figure 25A, was acceptable. However, at $Q = 3,940$ cfs, Figure 25B, the surface boil extended into the downstream channel.

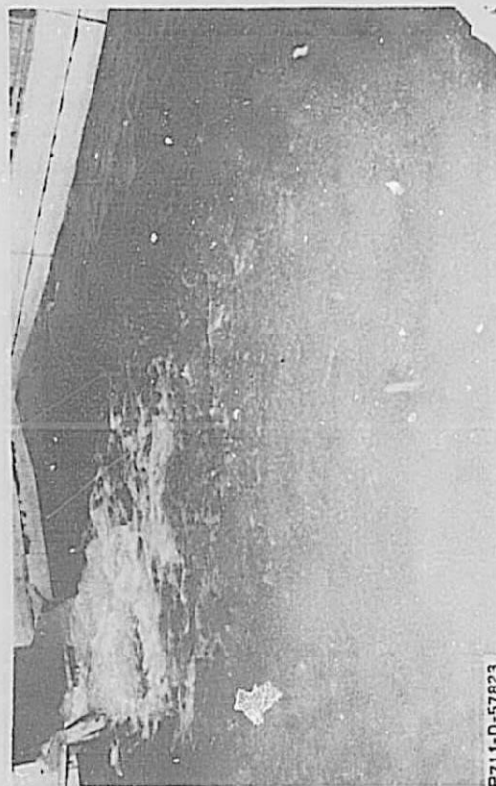
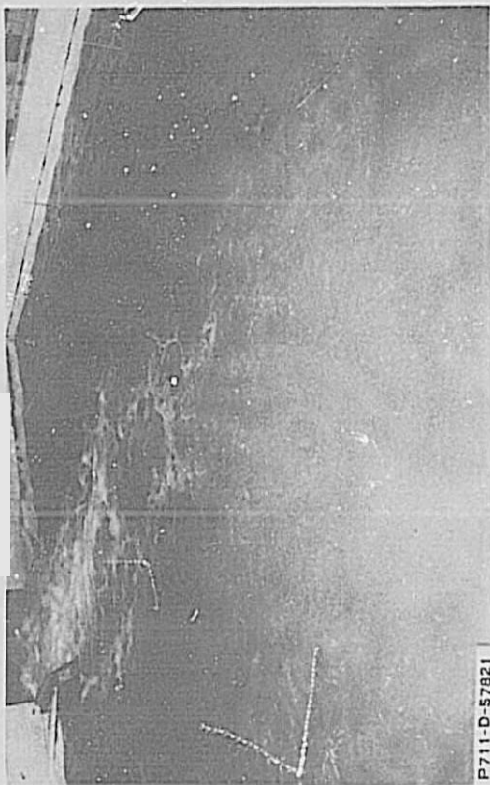
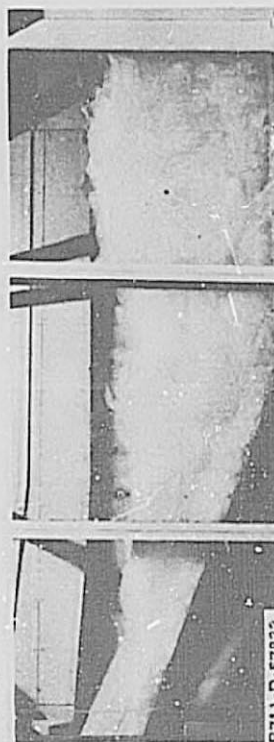
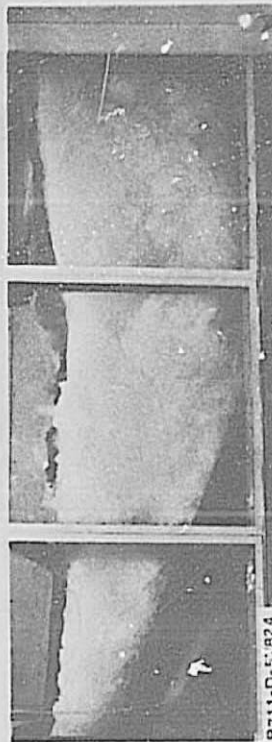
Figure 28
Report Hyd-573

With a reservoir elevation of 6000.0, Figure 28, operation was much improved and could be considered satisfactory.

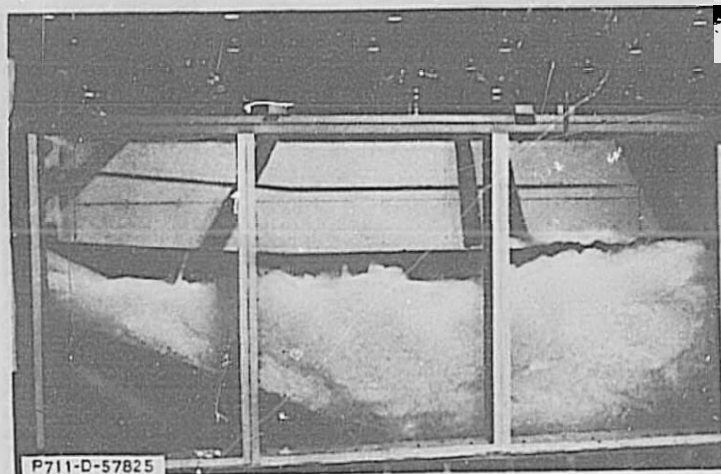
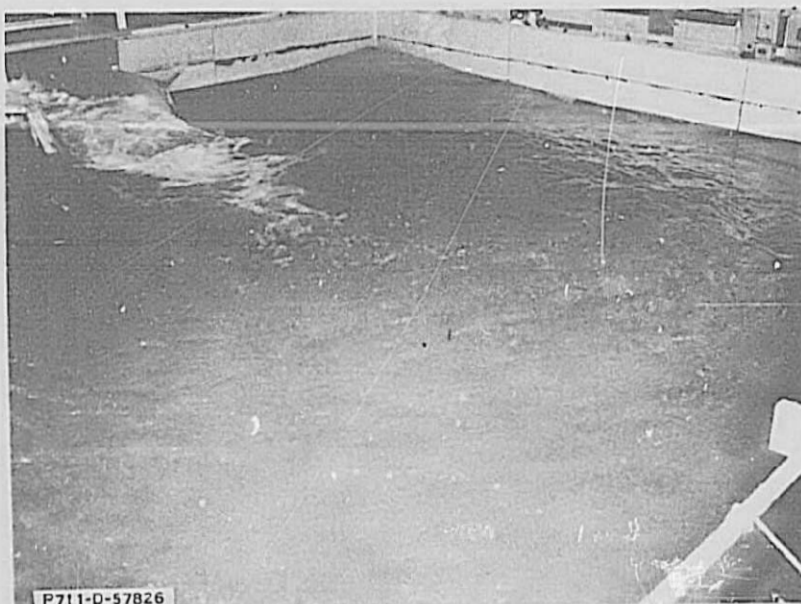
Figure 29
Report Hyd-573

The model was operated at a discharge of 3,200 cfs, reservoir elevation 6101.6, approximately 51 percent valve opening, tailwater elevation 5715.0, Figure 29. The jets moved along the floor to near the downstream end of the viewing section and at times turned upward before reaching the bottom of the chute. High surface boils occasionally overtopped the outside walls and there was some transverse surging in the basin. The jets influenced each other and the mainstream of the flow always moved along either the right or left side of the basin. Longitudinal surges carried through the basin into the downstream channel, causing fairly strong, well-defined waves. At tailwater elevation 5721.8, surface boils frequently overtopped the outside walls. The jets continued to influence each other and turned upward before reaching the bottom of the chute. Waves in the downstream channel were not as well defined and occurred randomly.

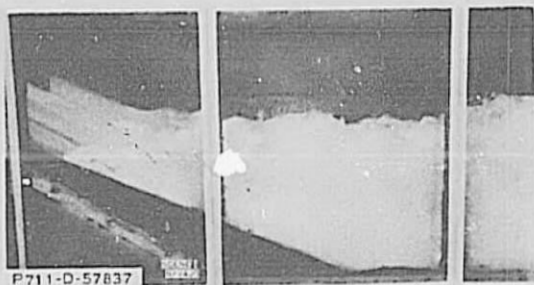
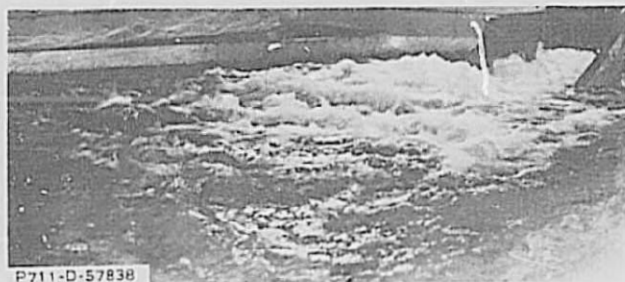
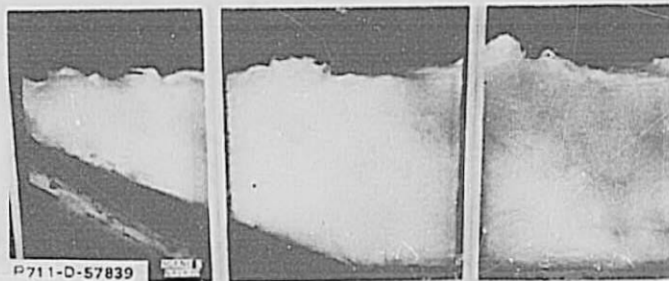
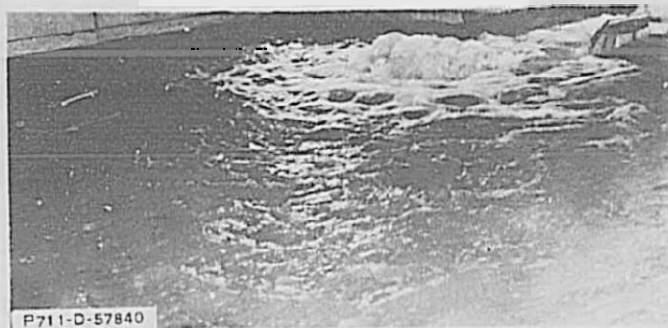
Figure 34
Report Hyd-573

Although not an expected operating condition, the maximum discharge capacity of 4,720 cfs was observed with the maximum reservoir elevation of 6101.6 and tailwater elevations 5715.5 and 5722.0, Figure 34. At the lower tailwater, turbulence was distributed throughout the basin and surface turbulence extended well into the downstream channel. At the higher tailwater elevation, conditions in the stilling basin were more unstable and strong longitudinal surges carried downstream. A pronounced surface boil occurred above the downstream end of the basin. However, wave action in the downstream channel was weaker than with the lower tailwater.

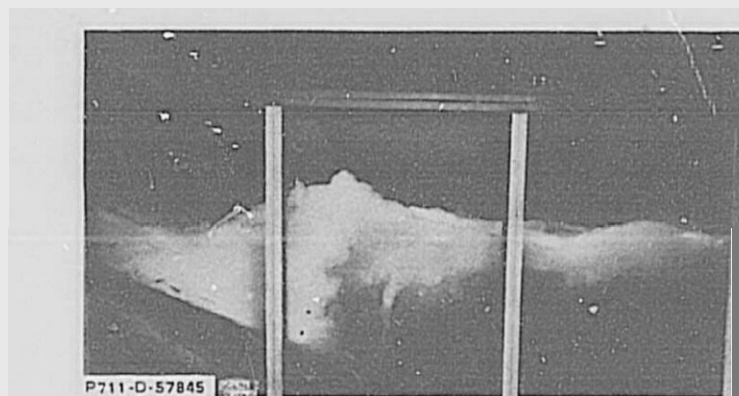
Figure 36
Report Hyd-573

For 1,500 cfs, reservoir elevation 6085, tailwater elevation 5714.3, Figure 36, the surface boil above the end of the chute increased in size and some splashing occurred over the outside walls. Surface conditions in the downstream channel were somewhat smoother than for the higher discharges.

Right-side view of stilling basin. $Q = 1,500$ cfs, both valves 22 percent open, reservoir elevation 6085, tailwater elevation 5714.3.

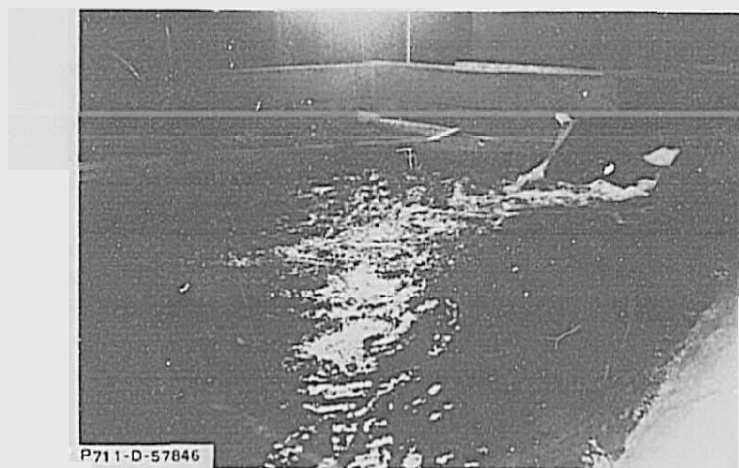
Flow conditions in downstream channel,
 $Q = 1,500$ cfs.

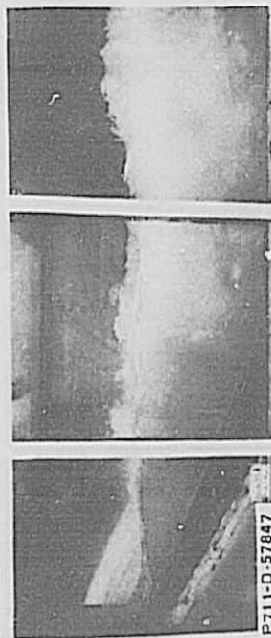
Right-side view of stilling basin. $Q = 2,790$ cfs, left valve alone 100 percent open, reservoir elevation 6101.6, tail-water elevation 5714.8.

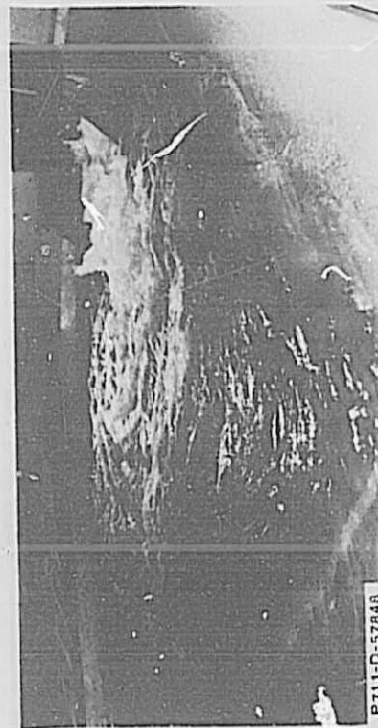
Flow conditions in downstream channel.
 $Q = 2,790$ cfs.

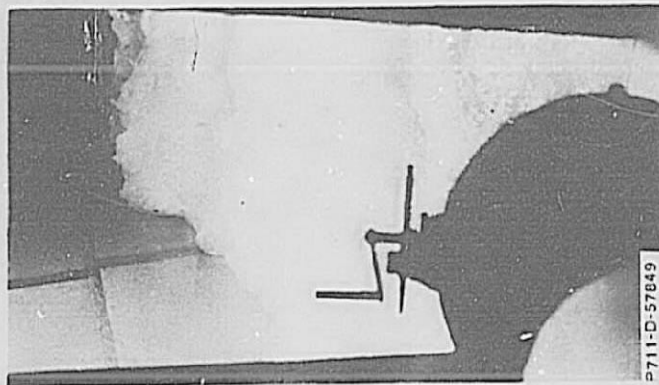
Figure 37
Report Hyd-573

Figure 37, resulted in expected very rough flow conditions and strong upstream flow along the right side of the basin. Surface turbulence extended into the downstream channel and caused strong wave action. Unsymmetrical operation of the outlets should be avoided.

View from near right valve, $Q = 2,790$ cfs.

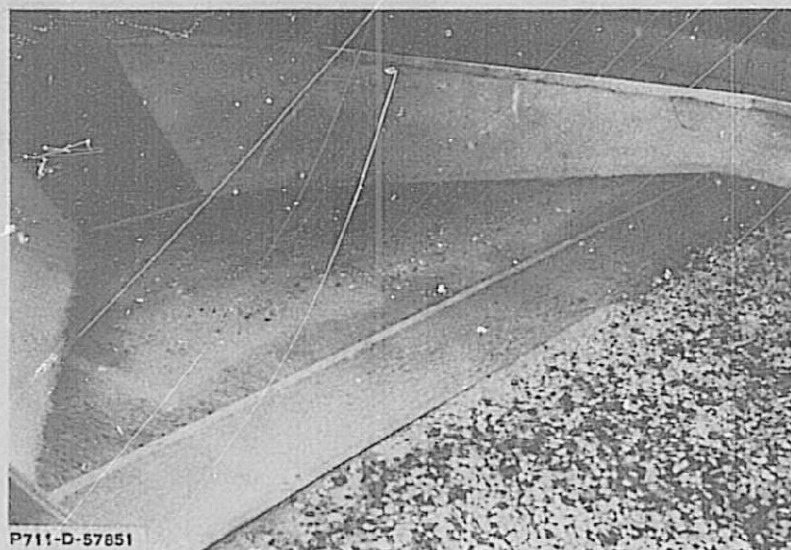
B. Location of material on paving before test with 36-inch-deep rock trap.

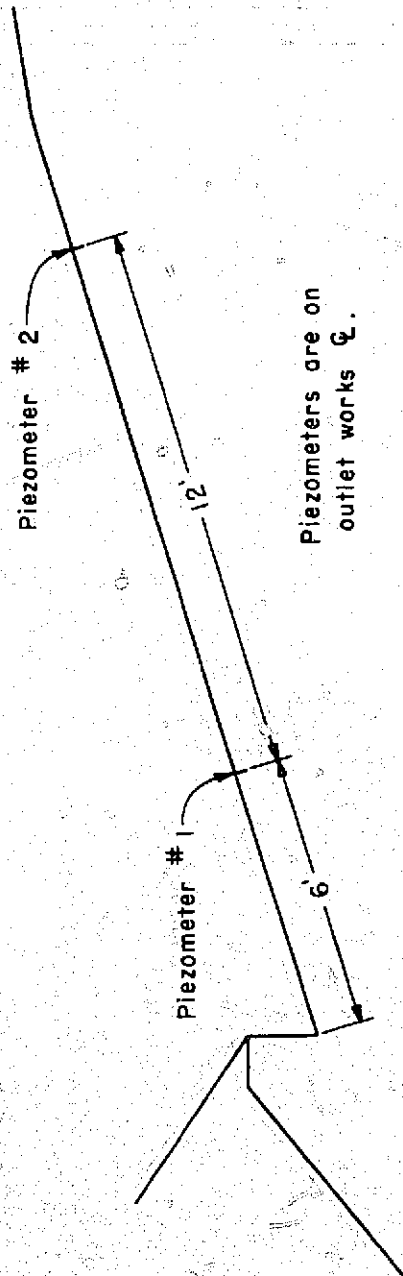
MAXIMUM FLUCTUATION, FT. OF WATER (PROTOTYPE)			
	Q = 3200 CFS Res. El. 6101.6 TW El. 5715.0	Q = 4720 CFS Res. El. 6101.6 TW El. 5715.5	Q = 4720 CFS Res. El. 6101.6 TW El. 5722.0
Piezometer # 1	0.0	0.5	0.5
Piezometer # 2	2.5	3.5	2.5

NAVAJO DAM OUTLET WORKS
1:12 SCALE MODEL
PRESSURE FLUCTUATION ON THE CONCRETE PAVING
IMMEDIATELY DOWNSTREAM FROM THE STILLING BASIN
RECOMMENDED DESIGN

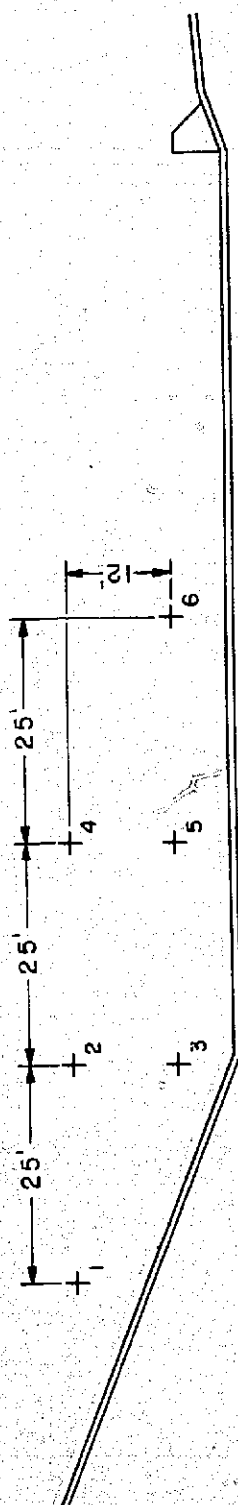
FIGURE 42
REPORT HYD-573

Pressures on the left wall. --Magnitudes and frequencies of pressures on the left wall of the stilling basin are shown in Table 6. Piezometer locations are shown in Figure 42.

NAVAJO DAM OUTLET WORKS
1:12 SCALE MODEL
LEFT WALL PIEZOMETERS - RECOMMENDED DESIGN

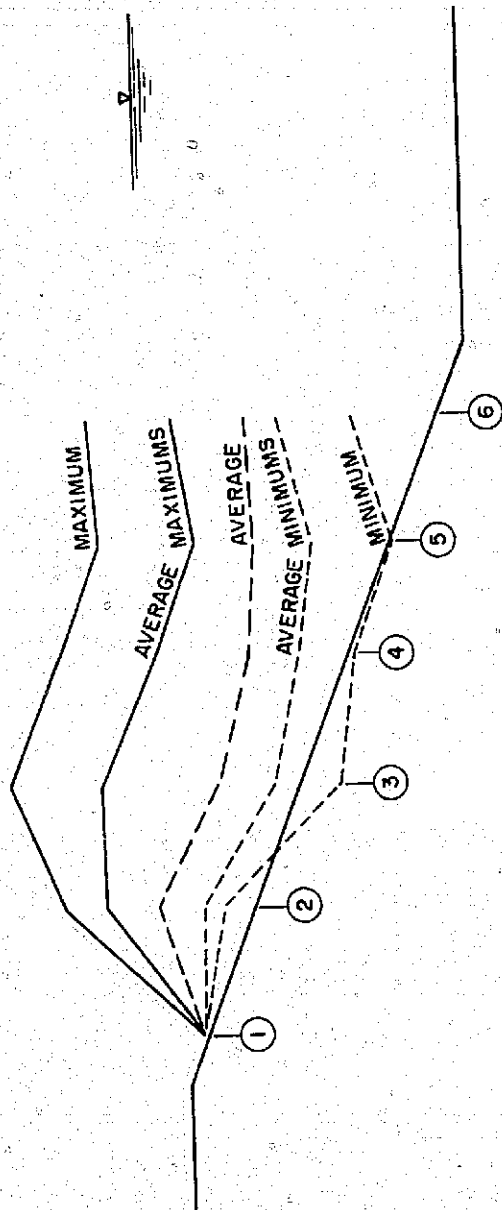
FIGURE 44
REPORT HYD.-573

NAVAJO DAM OUTLET WORKS
1:12 SCALE MODEL
INSTANTANEOUS PRESSURES ON THE CHUTE
FOR THE RECOMMENDED DESIGN

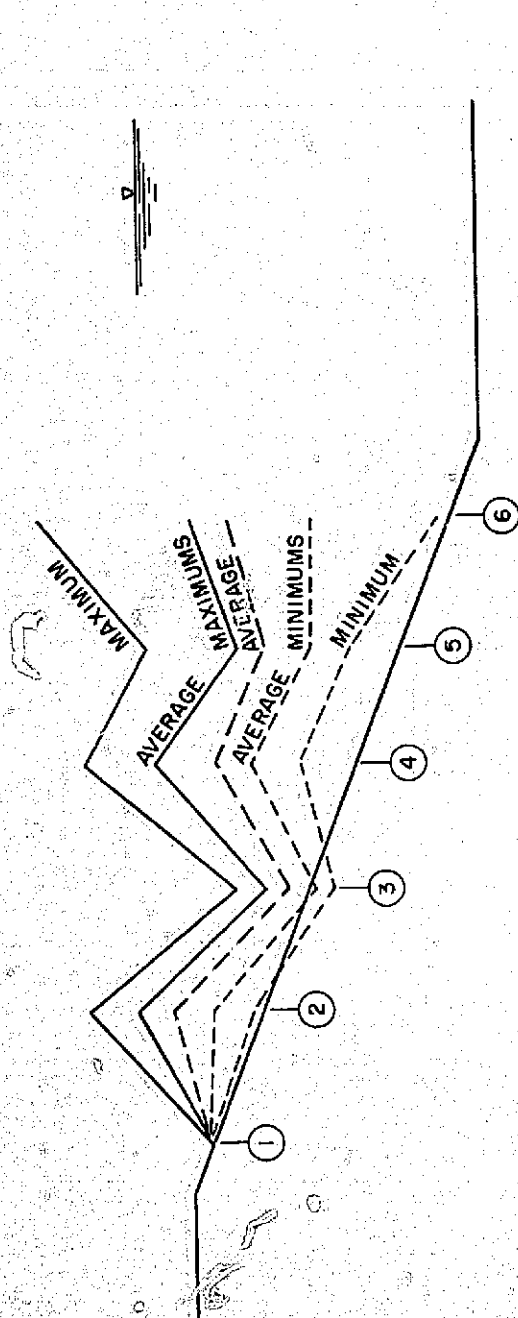
NAVAJO DAM OUTLET WORKS
1:12 SCALE MODEL
INSTANTANEOUS PRESSURES ON THE CHUTE
FOR THE RECOMMENDED DESIGN
